U.S. Department
of Transportation
**Federal Aviation
Administration**

General Aviation Airworthiness Alerts

AC No. 43-16

**ALERT NO. 221
DECEMBER 1996**

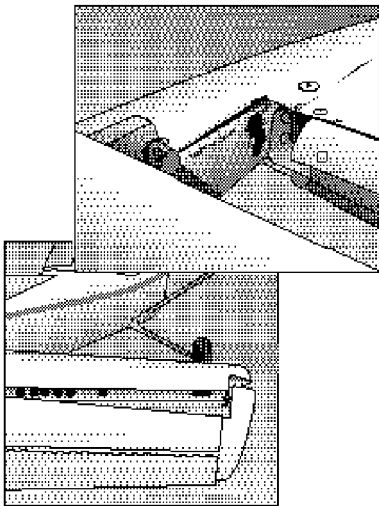
**Elevator Failure
5552**

This aircraft was being used for flight instruction. The student pilot informed the flight instructor, that during the flight, the elevator "did not feel right." The elevator system problem was not reported or entered into the maintenance records, and no action was taken. The next day, the right elevator hinge bracket failed completely during a student pilot solo flight. Although extreme difficulty was experienced in maintaining control of the aircraft, a safe landing was made.

The right elevator did not separate from the aircraft. (Refer to the following illustration.) While investigating the cause of this failure, the bushing (P/N 0432003-1) used for rotation of the parts was found conical shaped. The submitter speculated this was due to "wear and age." The small conical shaped area caused the end of the bushing to cut into the hinge brackets, causing the hole to elongate. The submitter suggested closer attention be given this area during scheduled and preflight inspections. In addition, the elevators should be removed each 1,000 hours for examination of the bushings for unusual wear patterns and/or corrosion. The hinge brackets should be checked for wear and the elevator spar for cracks. Proper lubrication of this area is vital to proper operation. This defect should have been discovered during preflight inspection. Slight hand pressure applied to the elevator surface in a "wiggling" motion would have revealed this dangerous problem.

Part total time-7,706 hours.
